**Melvin Price Locks and Dam UMR Mile 201**  
**Auxiliary Miter Gate Failure**  
**Bi-Weekly Status Report**  
**23 March 2005**

**General Description:** On 3 Oct 2004 the downstream miter gates on the auxiliary lock at Melvin Price Locks & Dam traveled past the mitered position, causing severe damage to the gates.

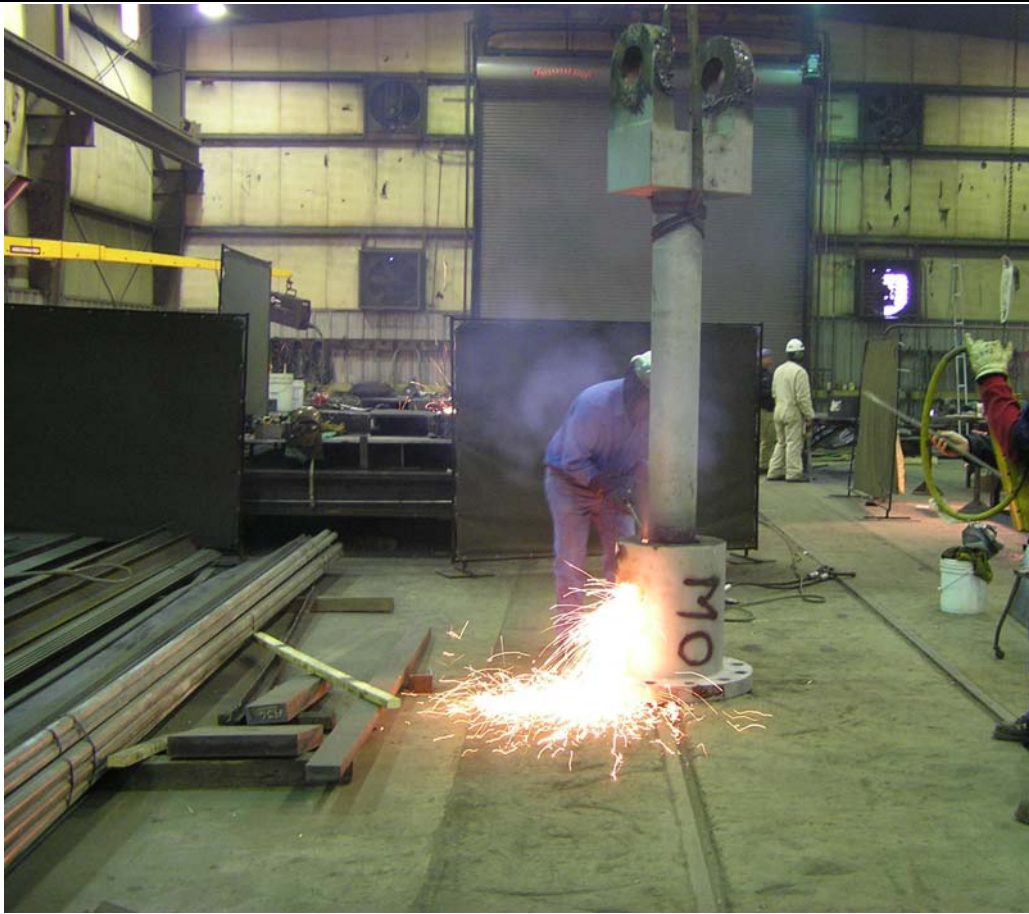
Crew members begin disassembling upper strut arms from auxiliary lock.

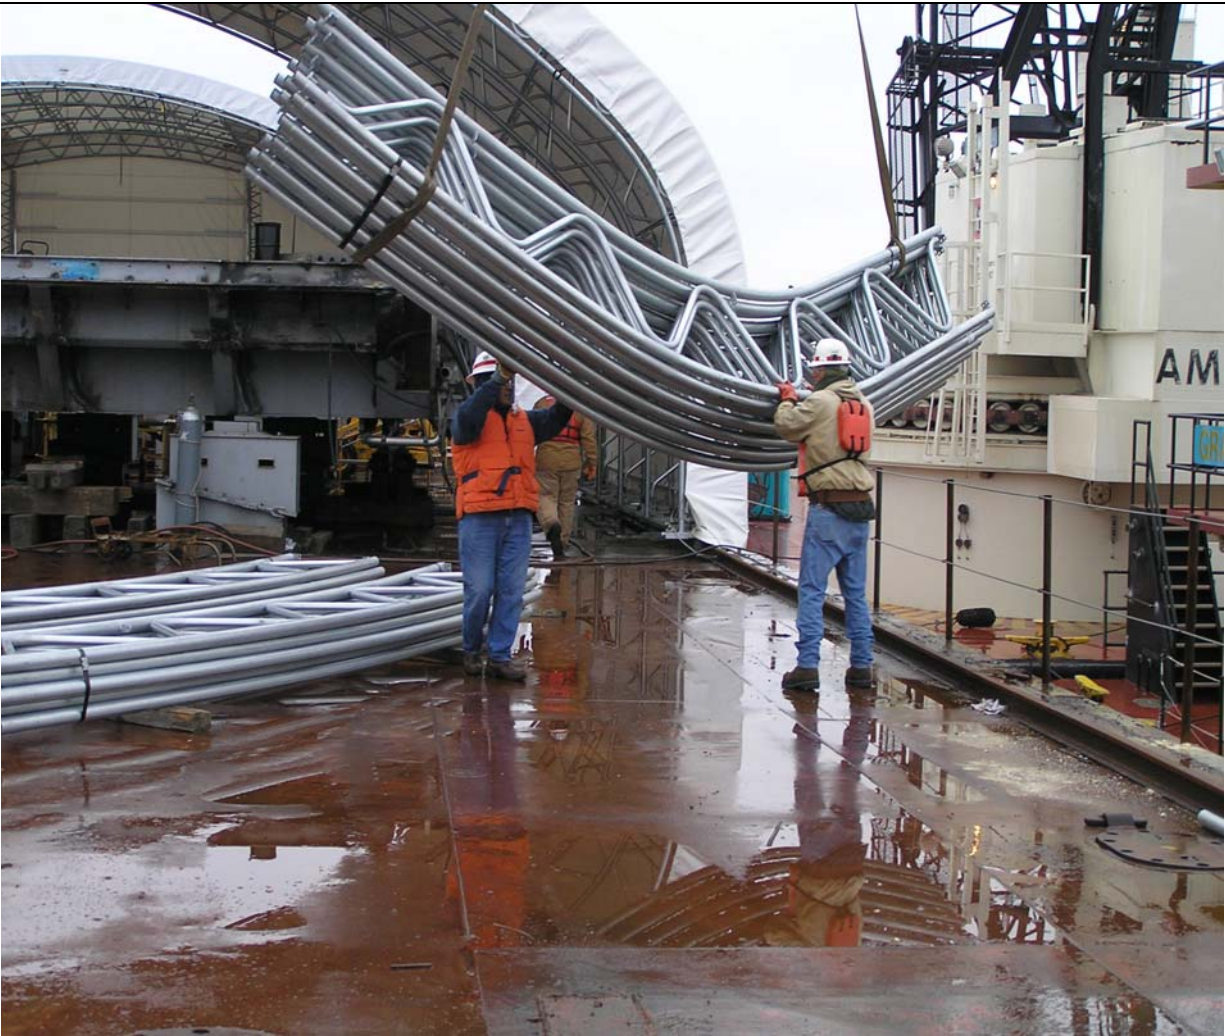
Combined Team lowers down frame sections of two 40ft environmental enclosure.  
23 Mar. 2005
